# Manhole Inspection Summary

Manhole # S19QQ\_018MH

Insp Date: **7/10/07 11:30 AM**

**Location** Address: **WOODBROOK-HOLMES**

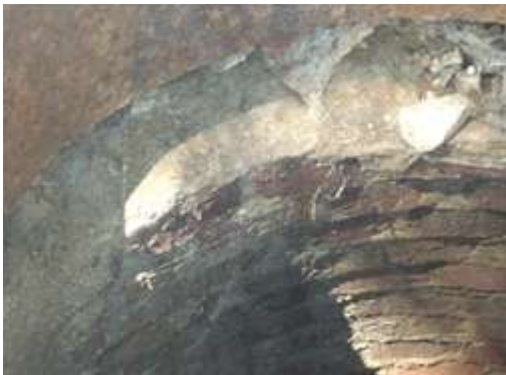
Defect 3

Condition: ☐ Sound ☐ Cracked ☐ Root Intrusion ☐ Loose Brick ☒ **Deteriorated**

DETERIORATION OF CHIMNEY

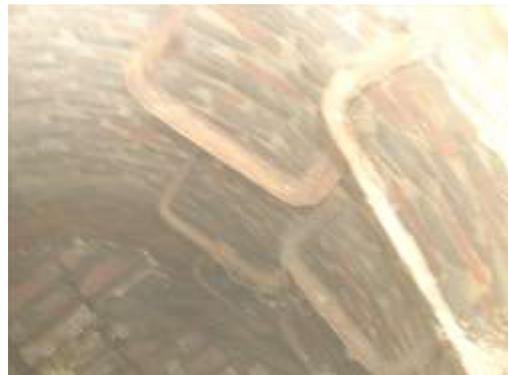
Defect 2

**Steps** Count: **6** Missing: **0** ☒ **Corroded**

CORRODED STEPS

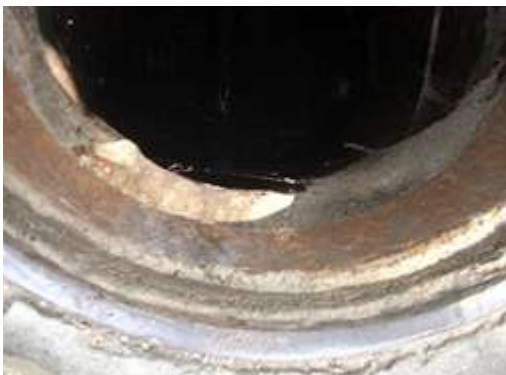
Defect 1

**Frame** Offset: **1** (in.) Condition: ☒ Sound ☐ Cracked ☐ Leaks

FRAME OFFSET

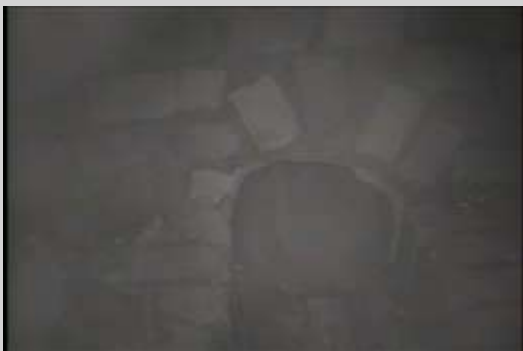
3 O'Clock Inflow

8 in. Circular Gravity Sewer  
Pipe In @ 3 O'Clock

Pipe Height: **8.4** (in.) Rod and Bar (Angled)  
Pipe Material: **Clay** ☐ Pipe Lined  
Invert Depth: **8.10** (ft.) Flow Characteristics: **Slow**  
Deposits: ☒ None ☐ Mud ☐ Sludge ☐ Debris ☐ Grease  
Silt Depth: (in.) Deposits Extent:  
Infiltration: **None** Pipe Seal Cond: **Broken**

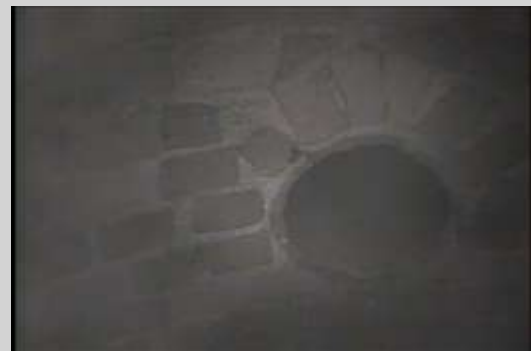
Drop In @ 3 O'Clock

Drop: **Outside** Rod and Bar  
Angled: **Yes** Reading: **9.81** (ft.)  
Inv Depth: **10.81** (ft.)  
Drop Condition: **Open**
